6RD-ABS-BC

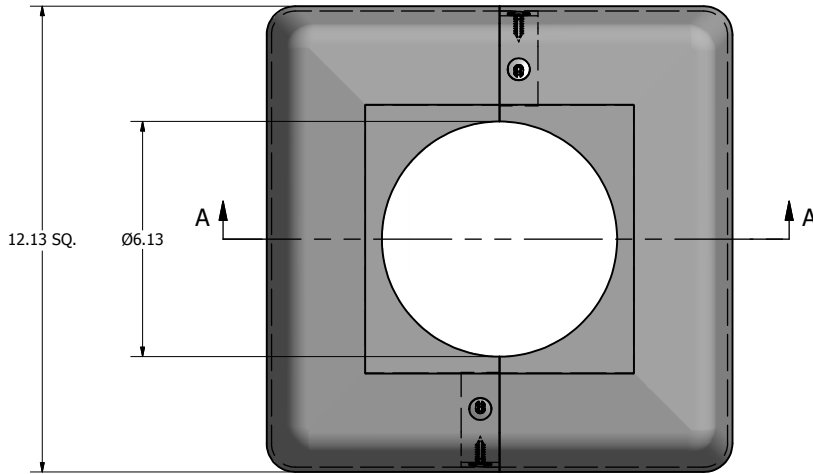
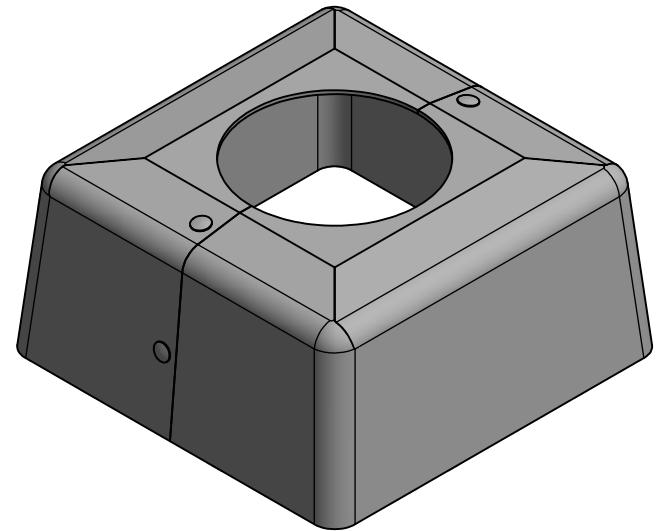
BASE COVER FASTENED TOGETHER WITH 4 PUSH PINS.
